U.S. PUBLIC LAND SURVEY MONUMENT LOCATION RECORD

USPLS CORNER: North 1/4 Corner SECTION: 26 TOWNSHIP: 37 NORTH RANGE: 9 East
 NAME OF WATERWAY FOR M.C. CORNER: N/A SECTION LINE: N/A
 (CITY)(VILLAGE)(TOWN) OF: Town of Pine Lake COUNTY OF: Oneida

U.S. PUBLIC LAND SURVEY MONUMENT RECORD

(a) Corner location: Township 37 North
 Range 09 East
 Town of PINE LAKE
 ONEIDA County, Wisconsin

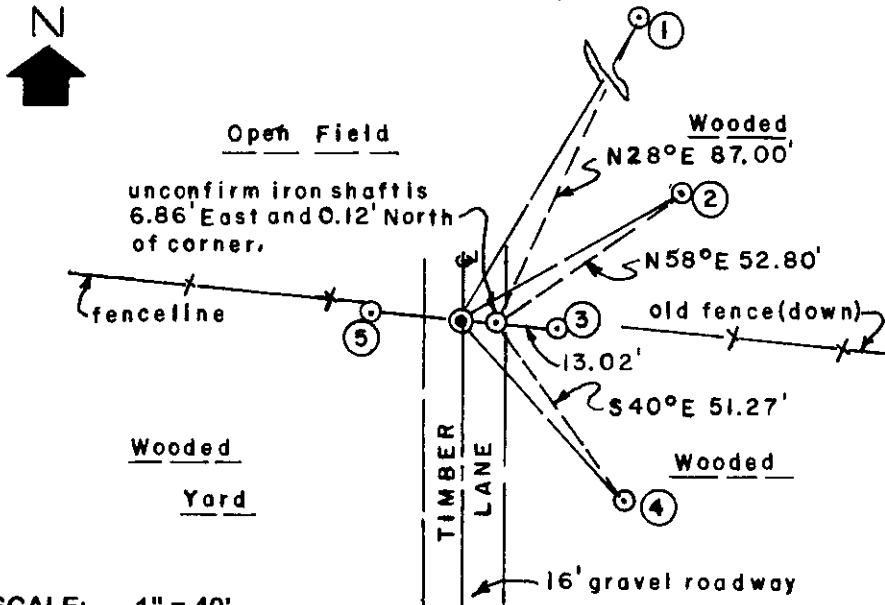
WITNESS MONUMENT TIES:

- ① Old BT 16" Pr with upper & lower blazes shut but plain, N30°E 90.22'.
- ② New BT 10" Pj N60°E 58.50' to PK nail and washer in left face.
- ③ 2" dia. aluminum pipe reference found with stamped Oneida County cap S85°E 19.88'; standard white poly 'T' marker post set 6" East.
- ④ New BT west 12" trunk of two Pw S42°E 56.11'.
- ⑤ 1" dia. by 24" long iron pipe set with Reference Mark cap flush with grade N85°W at 19.16'.

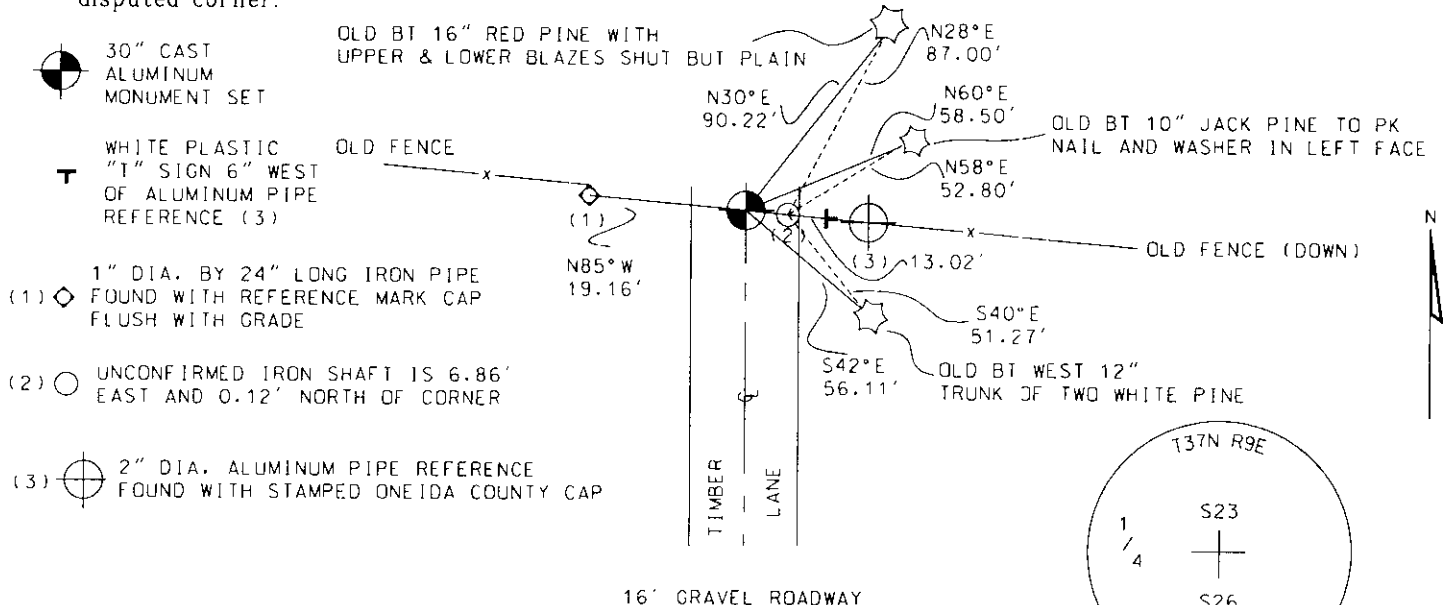
2002- 1" dia. iron pipe found and accepted by William G. Rhode in 1999, was missing - used existing ties and set Oneida County aluminum monument.
