U.S. PUBLIC LAND SURVEY MONUMENT LOCATION RECORD

USPLS CORNER: NORTH 1/4 SECTION: 24 TOWNSHIP: 38 NORTH RANGE: 10 EAST

(CITY)(VILLAGE)(TOWN) OF: THREE LAKES COUNTY OF: ONEIDA

U.S. PUBLIC LAND SURVEY MONUMENT RECORD

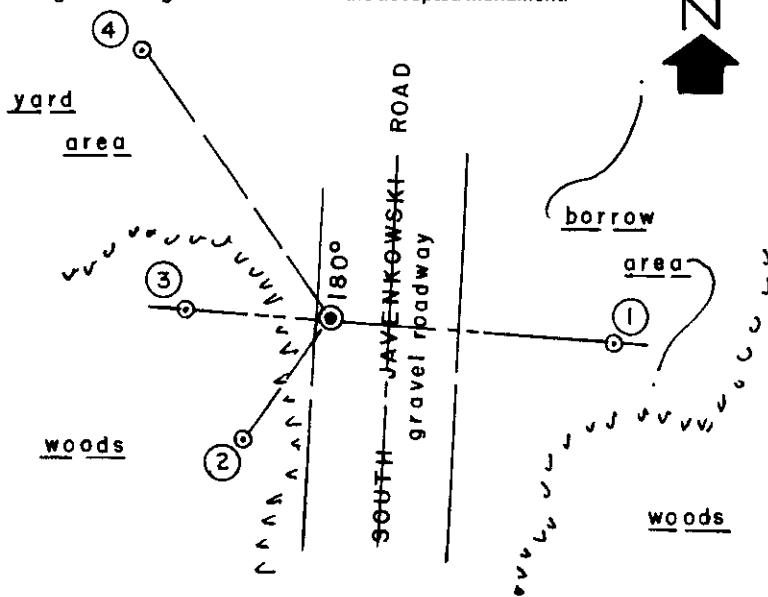
Found and accepted an undisturbed standard aluminum monument with stamped Oneida County cap 5" below west edge of existing gravel roadway surface; no other corner monumentation evidence observed nor detected with metal locator within roadway area.

WITNESS MONUMENT TIES:

- ① 1/2" dia. by 36" long steel rebar set with uncapped top 1" above grade in a rocks cairn S85°E 44.40'.
- ② New BT 5" Bw S36°W 23.24'.
- ③ Older 3/4" dia. iron pipe found with uncapped top flush in a rocks cairn N85°W 22.26'.
- ④ New BT 10" Mr N35°W 50.92'; no PK nail with BT washer set in face at DBH.

I set a standard white poly 'T' marker post 6" West of Witness Monument 1. Corner is located SE of Residence at Fire No. 6381.

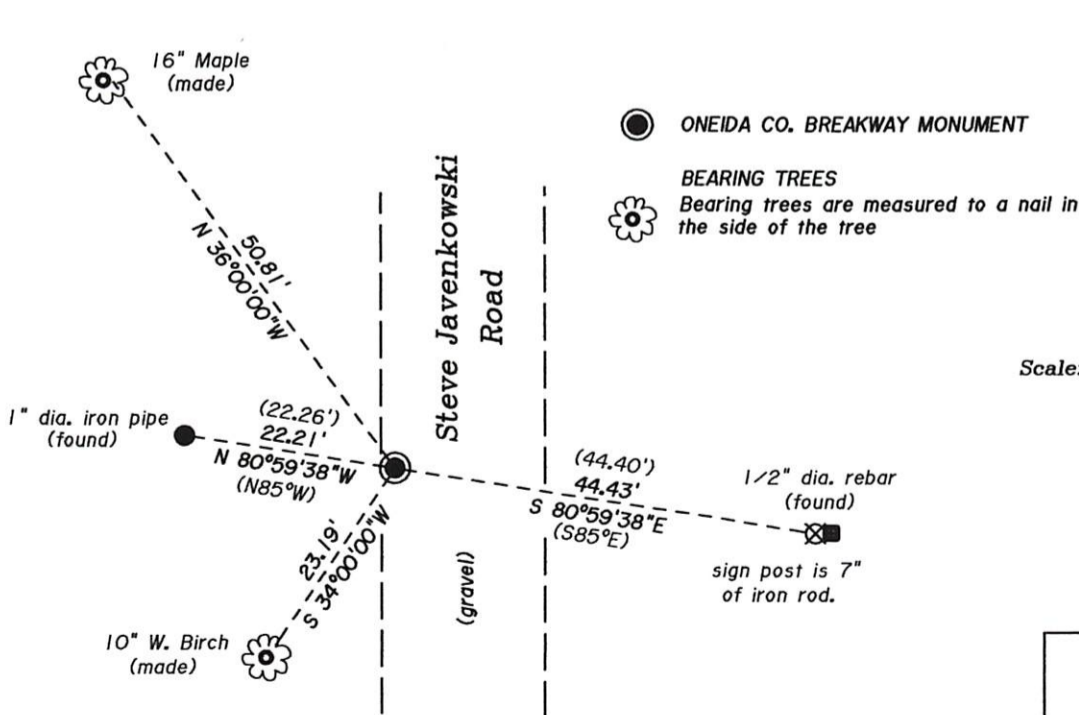
June, 2019: Thomas Boettcher of Eagle Landmark Surveying finds an Oneida Co. aluminum breakway monument 8" below the surface on the west edge of the road in good condition with existing corner ties as shown below.

December 2020: Thomas Boettcher returns to the site and found the aluminum monument now 12" deep due to new road gravel being added but falling on the edge of the new road resurfacing. I took a series of RTK GPS observations to average with the previous observations and checked the witnesses to the corner.
