# U.S. PUBLIC LAND SURVEY MONUMENT RECORD

(a) Corner location: Township 39 North Corner: NW Section Corner

Section 14 Range 8 East Original Surveyor: A. Anderson

County Oneida

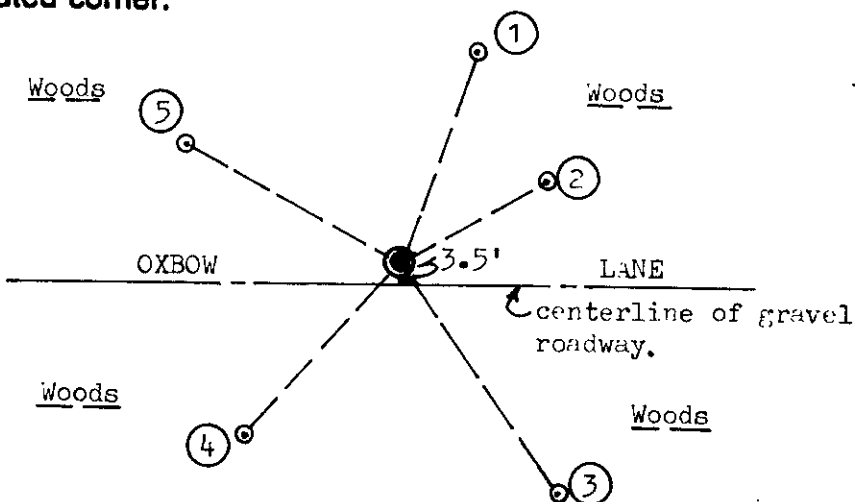
Standard 2" dia. iron pipe monument with stamped DNR brass cap found bent in existing road surface at this corner location. I carefully removed the 26" long monument and replaced it with a standard 2" dia. by 30" long aluminum monument with stamped Oneida County cap 12" below the existing road surface grade. I left the bent iron pipe monument flat on ground along west side of SW reference monument described below, and also set a standard white poly 'T' corner marker post 4" South of the SW reference monument. Both reference monument caps SW and SE stamped with 'RM' and an arrow pointer toward corner monument. All original GLO corner evidence is now obliterated. In 1938, Wisconsin Valley Improvement Company set a 2" iron pipe at this corner by section line resurvey, and marked a 12" Pn N59°E 0.439 ch and a 14" Pn S29°W 0.617 ch as BTs. In 1990, Kimbal, et al, Wis DNR noted WVIC iron pipe gone in roadway, but found NE Pn BT by WVIC in 1938 as a rotting stump, and SW Pn BT by WVIC in 1938 as a 22" Pn, which were used to reset the corner location with a 2" dia. iron pipe monument with stamped brass cap in existing roadway; and marked new BTs I found and used for new ties below. Each 1990 BT has a PK nail with washer in right face as tie point and an upper face blaze with 'BT' scribe. They also tied record BT 22" Pn S33°W 40.72' which I also found OK. Recovery completed July 28, 1997; no witnesses.

- ① 24" Pw BT N20°E 34.61'.
- ② 12" Mr BT N60°E 25.93' to middle trunk of triple.
- ③ Standard 2" dia. x 30" long aluminum monument set with stamped Oneida County cap, S34°E 44.27'.
- ④ Same monument as No. 3 S42°W 36.18'.
- ⑤ 12" Mr BT N61°W 38.33' to right trunk of twin.
