U.S. PUBLIC LAND SURVEY MONUMENT RECORD

(a) Corner location: Township 38 North Corner: West 1/4 Corner

Section 19 Range 8 East Original Surveyor: Alfred Millard

County Oneida

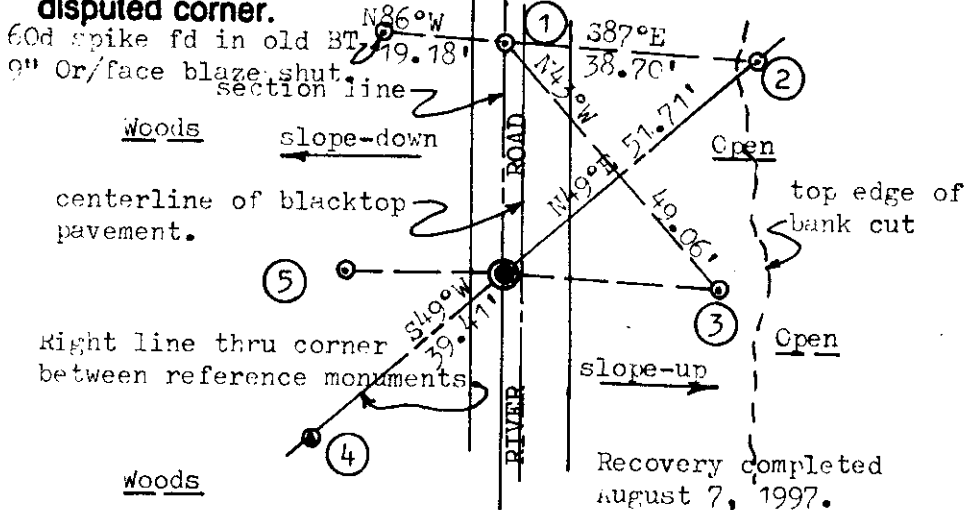
Witness Monument Ties:

- ① 3/4" dia. iron pipe found flush in blacktop pavement North 36.03'.
- ② Found 1/2" dia. iron rod with stamped Oneida Co. aluminum cap flush with grade; set by RLS 1234/Rein in 1992.
- ④ 3/4" dia. iron pipe found with RLS 1234/Wild Surv cap in top S86°E 33.40'.
- ⑤ New BT 9" Or N88°W 25.14'; East trunk of double.
