U.S. PUBLIC LAND SURVEY MONUMENT RECORD

(a) Corner location: Township 38 North
 Range 8 East West
 Town/City/Village of NEWBOLD
 County of ONEIDA

U.S. PUBLIC LAND SURVEY MONUMENT LOCATION RECORD

CORNER: NW Section SECTION: 5 TOWNSHIP 37 NORTH RANGE 8 EAST/WEST

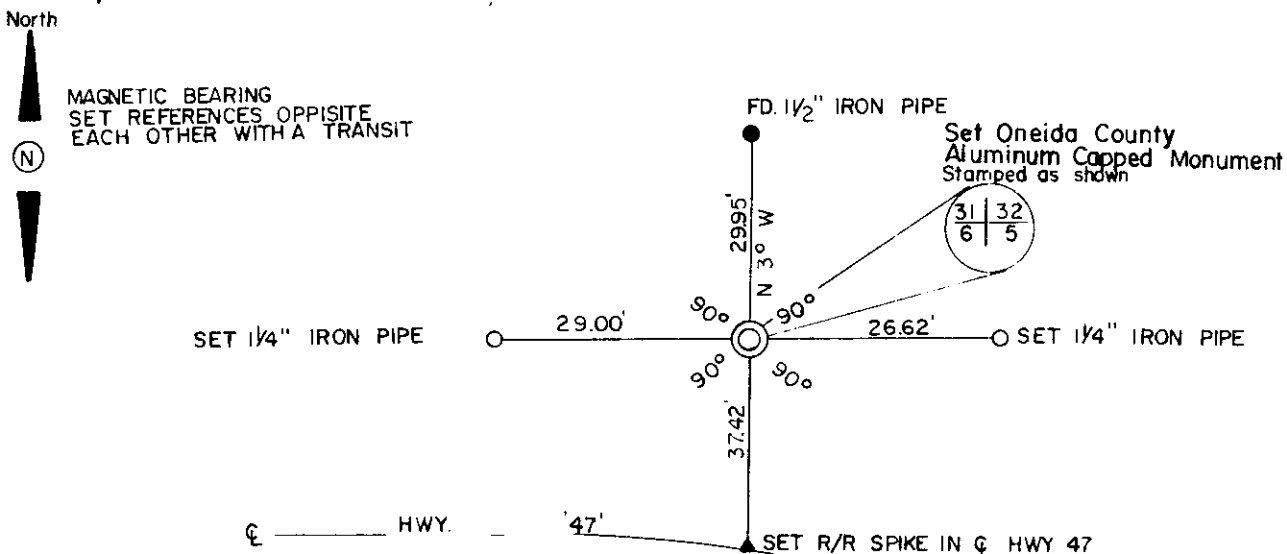
At the corner I found no evidence of original corner. I re-established the corner from Genisot Map # 6388 (Schmit). This position checks to the north with that of R.E. BAndows distances.. Hwy. 47 has been reconstructed and the corner now is in the side slope of the highway which agrees with the extention of the center line of the road to the east. I set an Oneida County Aluminum Capped monument and witnessed it as shown below.

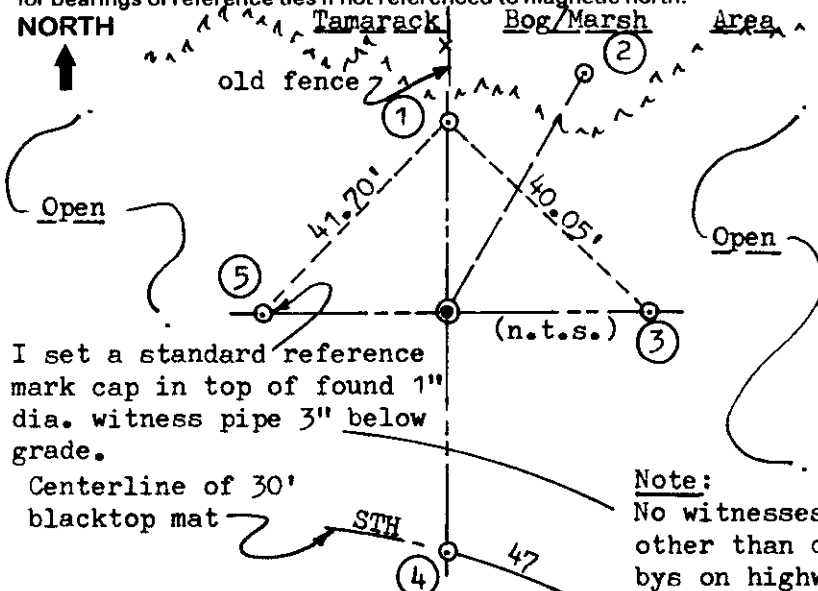
Note: Removed/replaced monuments were left flat on grade next to new monuments set. This corner location was reestablished by M. J. Romportl/Genisot & Associates, Inc. of Rhinelander, Wis. per USPLS Monument Location Record dated Dec. 4, 1984 filed in Oneida County records; however, his standard 2" dia. aluminum pipe monument set at the corner with stamped Oneida Co. cap was found bent and without cap 3" below existing grade, his North and East witness iron pipe monuments were found tipped and his railroad spike South in blacktop pavement centerline was gone. Upon notice to Romportl, now Oneida County Surveyor, he approved restoration of the corner location. Therefore, I pulled the damaged aluminum pipe monument and reset the corner with a new 2" dia. by 30" long aluminum pipe monument with stamped Oneida County cap flush with existing grade. I then pulled the tipped old 1 1/4" dia. by 36" long uncapped iron pipe at his North witness corner and reset it with a 1" dia. by 24" long iron pipe with standard reference mark cap 1 1/2" below grade. I then removed the tipped old 1 1/4" dia. by 18" iron pipe at his East witness corner and reset it with a 1" dia. by 24" long iron pipe with standard reference mark cap 2" below existing grade. I then set a 3/4" dia. by 12" long steel shaft in the hole left by his RR spike in centerline joint of existing blacktop pavement South of the corner monument. I also used a transit to check that all four(4) witness monuments were on a right line thru the corner center and measured new ties indicated below. The corner falls about midway down the bank of highway fill section to level of adjoining tamarack bog/marsh area. I reset a found poly 'T' marker post 4" South of the corner monument. Recovery completed September 15, 1998.

I set a standard reference mark cap in top of found 1" dia. witness pipe 3" below grade.

Note:
No witnesses other than drive-bys on highway.

- ① Found old 1 1/4" dia. x 36" I.P. tipped North which I pulled and reset with a 1" dia. x 24" I.P. with standard reference mark cap 1 1/2" below grade, North 29.95'.
- ③ Reset an old 1 1/4" x 18" I.P. tipped 45° SE with a 1" dia. x 24" I.P. with standard reference mark cap 2" below grade, East 26.65'.
- ② New BT 8" Tam N19°E 42.82'.
- ④ Record RR spike gone but found its hole in pavement centerline where I set a 3/4" dia. by 12" long steel shaft flush, South 37.50'.
- ⑤ 1" dia. I.P. found OK 1 1/2" below grade, West 29.08'.
