U.S. PUBLIC LAND SURVEY MONUMENT RECORD

ONEIDA COUNTY, WISCONSIN

COUNTY INDEX NO: L 25
 WI CORNER IDENTIFICATION NO: 43809132000

SECTION 13
 TOWNSHIP 38
 RANGE 9

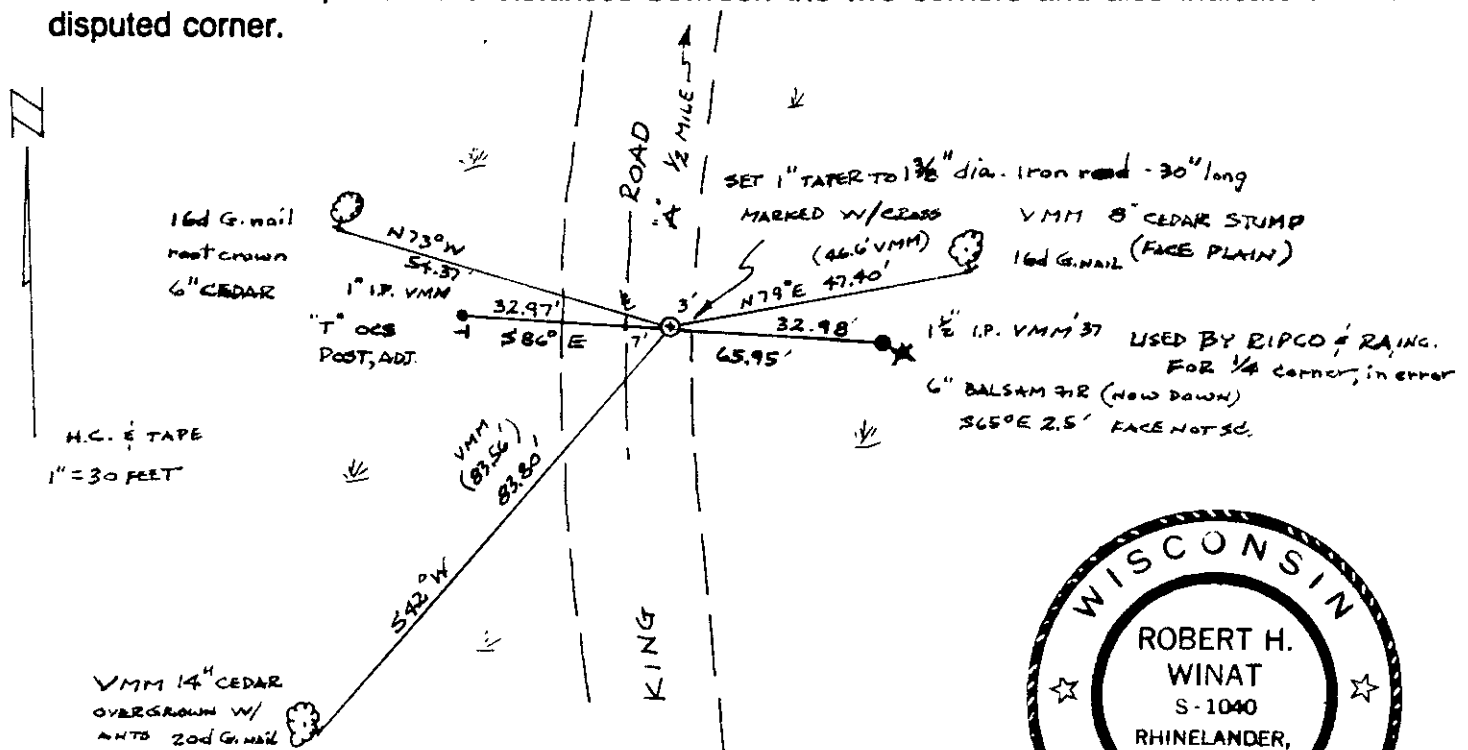
(c) (d) (e) Plan view of corner with ties to at least 4 witness monuments. If in disagreement with previously established corner, show the distances between the two corners and also indicate the ties to the disputed corner.

Original; Hiram C. Fellows, 18 July, 1859 North betwn. Sec. 13 & 18 var 8°E, 0.00 chns; 15.50 chns enter tamarac swamp bears E&W; 40.00 chns set 1/4 post, Cedar 8", N30°W, 15 lks. and Cedar 14", S67°E, 5 lks.; 71.00 chns leave cedar & tamarac swamp bears NE&SW.... OCS, Dorr & Vaughan's field notes, pg. 247... NE corner Section 13... run south, var 2 1/2° E, 39.72 chns. hit E 1/4 post; found east tree ok!... 28 June 1910, D.H. Vaughan, OCS. V.M. Maine, OCS, 10 May '37, At 1/4 corner... identified by stp, cut high, of orig. B.T.-marks plain, viz; Cedar 14" S67°E, .05 chn., also old scribed stake on east side of road. Offset iron pipes 2 rods E&W; boxed two new B.T.'s..... not scribed, viz; Cedar 8" S40°W, 1.266 chns. and Cedar 10" N76°E, .706 chns. Resurveys by RIPC0 '62 & Robinson & Assoc. '78 used the east witness iron pipe for the 1/4 corner... iron pipe 40 feet east of centerline. NOTE: VMM notes not available until 1990. 1 Jun '91, I find VMM's witness pipes and bt's ok! 8 Jun '91, I set 1-3/8" iron shaft, with cross, flush in pav't. for corner; make ties as shown below to preserve corner.

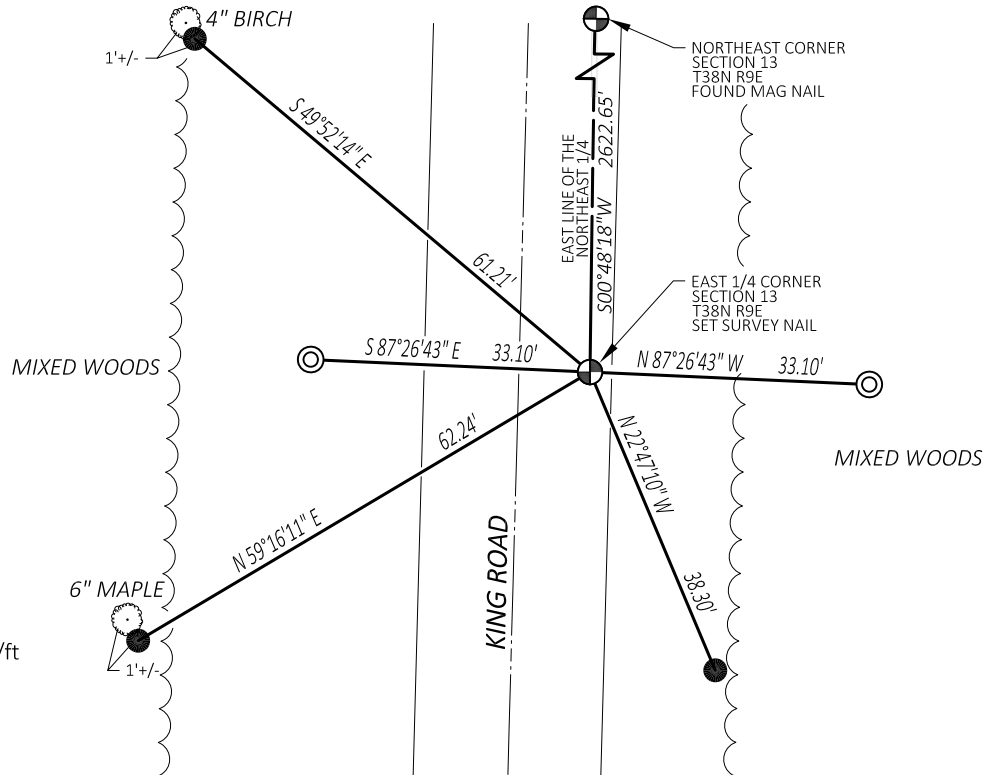
PLAN VIEW

2025: KING ROAD WAS RECENTLY RAISED AND RE-PAVED, LIKELY THE CORNER WAS OBLITERATED DURING THIS PROJECT. I FOUND THE TWO IRON PIPE WITNESSES AND REMNANTS OF ALL 3 BEARING TREES WITH NAILS FROM R. WINAT'S TIE SHEET. SEVERAL OF THE BT'S WERE FALLING OVER AND DETERIORATED. THE FOUND IRON PIPES WERE STILL STABLE AND IN GOOD CONDITION. TO RE-ESTABLISH THIS OBLITERATED CORNER, I BEST FIT THE BEARING TREES AS WELL AS THE 2 IRON PIPE WITNESSES. SET A SURVEY NAIL AT CORNER LOCATION, SET 3 NEW TIES AND RE-TIED CORNER.

NOTE: CORNER FALLS 8.5' +/- EAST OF THE CENTERLINE OF KING ROAD.
