**U.S. PUBLIC LAND SURVEY MONUMENT LOCATION RECORD**

USPLS CORNER: SOUTH WIT MC SECTION: 14 TOWNSHIP: 38 NORTH RANGE: 10 EAST  
 NAME OF WATERWAY FOR M.C. CORNER: THUNDER LAKE SECTION LINE: WEST  
 (CITY)(VILLAGE)(TOWN) OF: THREE LAKES COUNTY OF: ONEIDA

# U.S. PUBLIC LAND SURVEY MONUMENT RECORD

(a) CORNER LOCATION: South W.C.  
Meander Corner Corner of Section 14  
 Township 38 North, Range 10 East  
 Township/City Three Lakes  
 County of Oneida

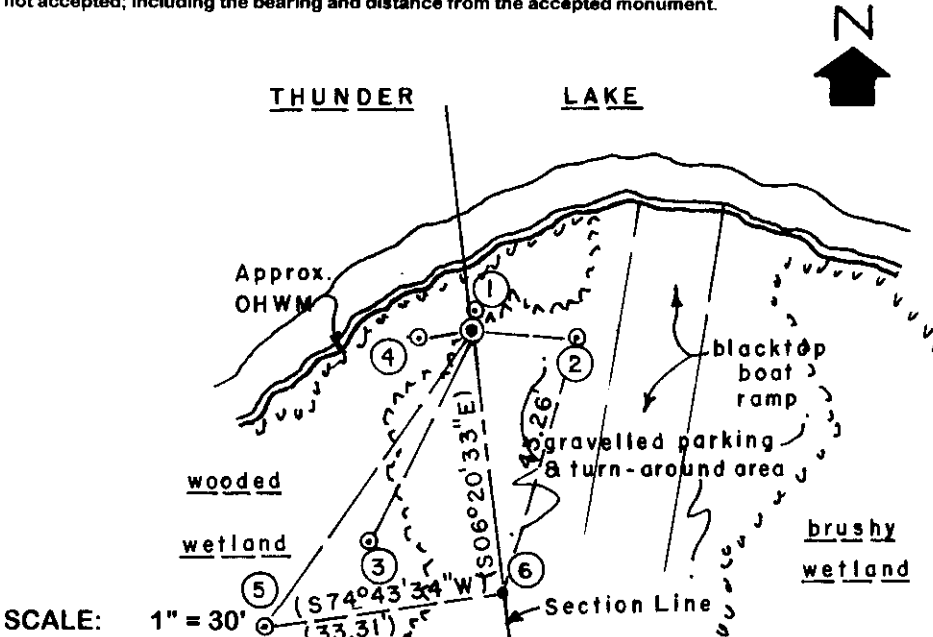
I could not find 1" iron pipe noted as a witness MC per plat of survey by Kip Soder/RLS 1731 filed as B-3743 in Oneida County survey records and dated July 1997. However, I did find an old 1.25" dia. galvanized iron pipe well point with uncapped top 15" above grade at the NE corner of Lot 1 of said plat of survey B-3743, which I verified with Kip Soder by phone call; therefore, I reestablished the section line therefrom by record bearing and distance offset and south to the SW section corner I had also recovered this date, and set a 1/2" dia. by 36" long steel rebar with a 1" dia. by 24" long iron pipe driven over it at top 2" above grade, as a new witness MC, on an extension of the section line toward the south shore of Thunder Lake.

- WITNESS MONUMENT TIES:**
- ① Old 9" Bw BT with face blaze open N10°E 2.90'; no record.
  - ② 3/4" dia. steel shaft found with an RLS 1760 cap 2" below grade S89°E 16.20'; did not accept as a Wit MC as obviously erroneous.
  - ③ New BT 8" Bw S26°W 37.07'.
  - ④ New BT 9" Bw S82°W 8.81'.
  - ⑤ 1.25" dia. iron pipe well point found 15" up S34°W 57.70'; is also S74°30'W 33.31' from Wit. Mon. 6.
  - ⑥ 7/16" dia. by 8" spike set S06°E 42.12' at Wit MC per Soder survey.

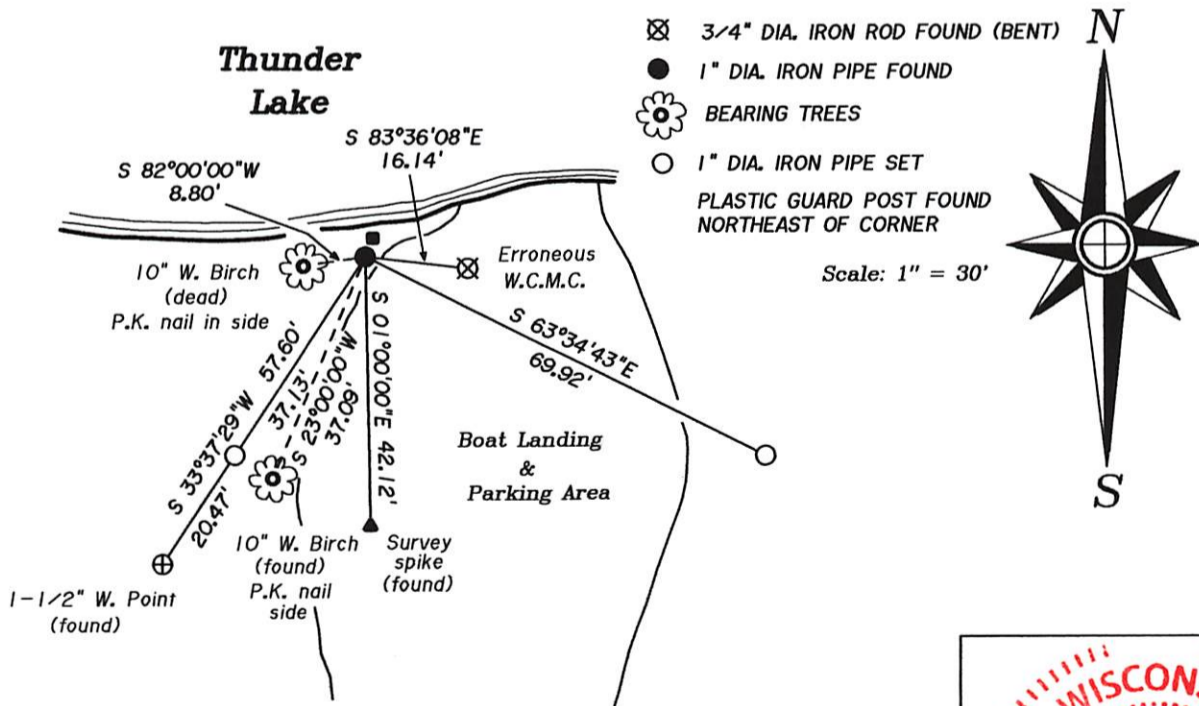
6-03-2019: Thomas Boettcher of Eagle Landmark Surveying find the W.C.M.C. in good condition with the following references as shown below:

December 2020: I, Thomas Boettcher, returned to the site and found the 1" iron pipe in place. I took a series of RTK GPS observations to average with the former observations. I also checked the witnesses to the corner as shown below.
