# U.S. PUBLIC LAND SURVEY MONUMENT RECORD

**(a) CORNER LOCATION:**  
 North 1/4 Corner of Section 16  
 Township 39 North, Range 11 East  
 Township/City Three Lakes  
 County of Oneida

Index No. 3911090020

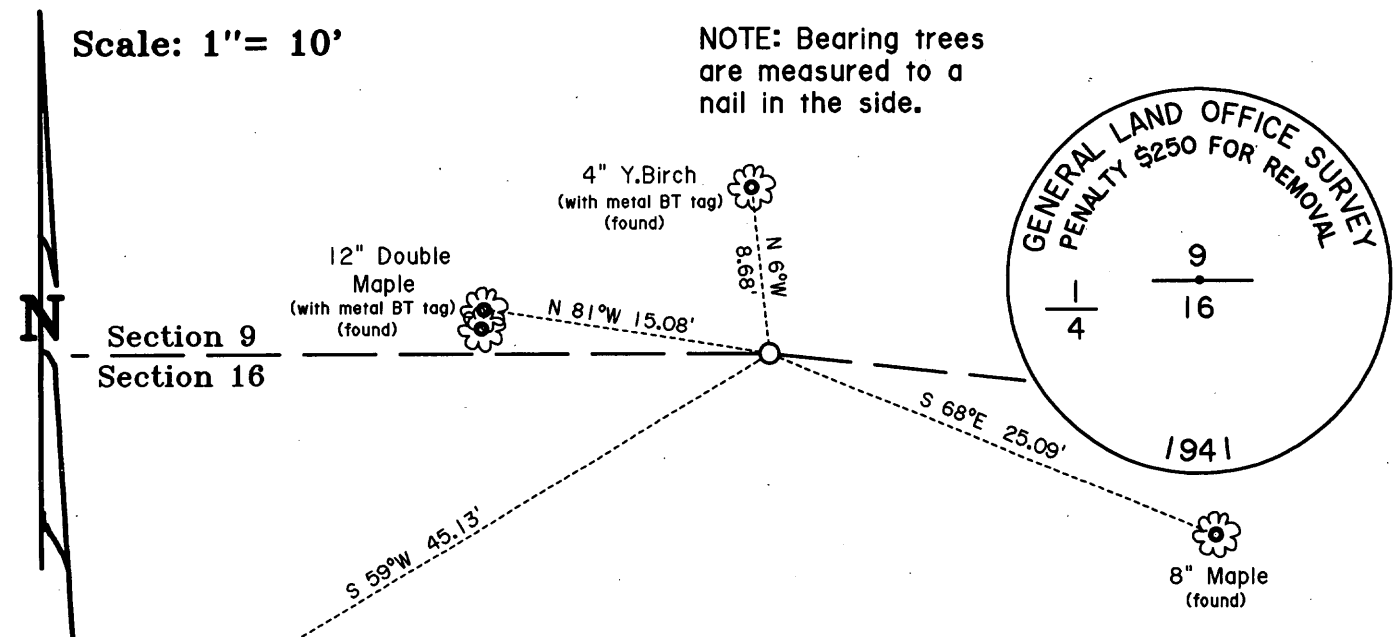
**(c)(d)(e) Plan view of the corner with ties to at least 4 witness monuments. If in disagreement with previously established corner, show the distances between the two corners and also indicate the ties to the disputed.**

February 1, 1012: I, Thomas A. Boettcher, found the above described GLO 6" diameter concrete monument with a brass cap stamped as shown below flush with the ground and in good condition. In our survey in Section 16 we measured to the Northeast section corner and check with the GLO distance within one foot and GLO angle from the East section line check within about one minute. This position checks well with the GLO survey. We found four existing BT's as shown below, two with metal BT tags. We also found a metal sign post 3' southwest of the corner. We set a plastic sign post 0.8' North of the corner. We did not find the GLO 1941 BT's since this area has been logged years ago.
