U.S. PUBLIC LAND SURVEY MONUMENT RECORD

(a) Corner location: Township 37 North

Range 11 East/~~West~~

County Oneida

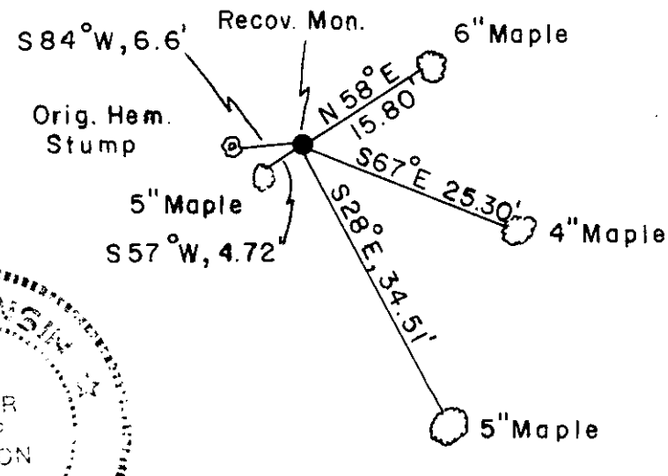
Recovered Monument

Recovered a 2-1/2" iron pipe with brass cap.
Previous recoveries of W.A. Maine would indicate this to be his monument. No notes to verify it.
Recovered original BT - Hemlock 19" S84 W 10 LKs. Now a large decaying stump.

2-1/2" I.P. - B.C.
