U.S. PUBLIC LAND SURVEY MONUMENT RECORD

(a) Corner location: Township 39 North **Corner:** NW Section Corner

Section 33 Range 8 East **Original Surveyor:** A. Anderson

~~Town/City/Village~~ Newbold **Original B.T.'s:** 12" A N53°E 17 lks
20" Py S71°W 48 lks

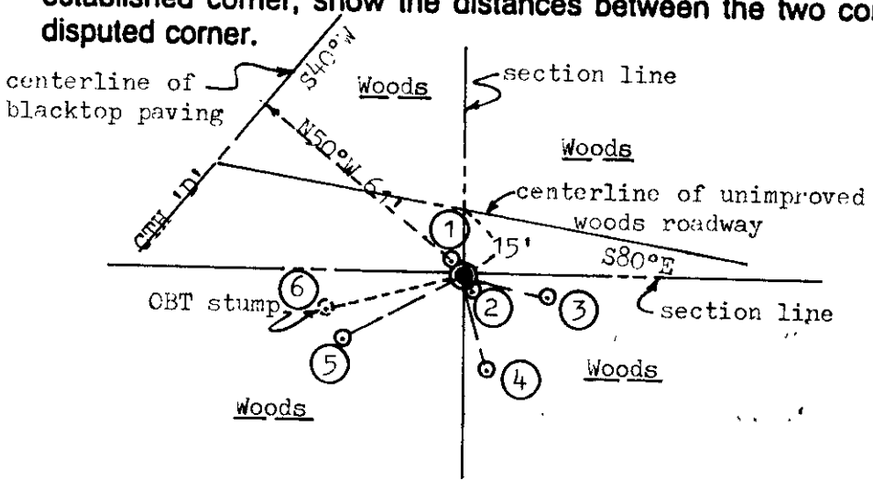
Witness Monument Ties:

1. Old BT 9" Or N43°W 4.19'.
2. New BT 11" Aspen S30°E 4.02'; WCD Aluminum locator plate fd on North face 5' high.
3. Record BT 17" Or S77°E 19.42'.
4. New BT 12" Or S14°E 21.95'; North trunk of twin.
5. New BT 13" Or S62°W 31.17'.
6. OBT stump S77°W 31.7' to old face; fire charred, signs of axe work.
