# U.S. PUBLIC LAND SURVEY MONUMENT RECORD

(a) CORNER LOCATION: Southeast Corner of Section 19  
Township 38 North  
Range 5 East  
Town of Minocqua  
County of Oneida

COORDINATES  
North: 210056.729  
East: 139593.338  
Projection: WISCORS - Oneida  
Datum: NAD 1983(2011)  
Method: computed, based on witnesses RTK - Direct

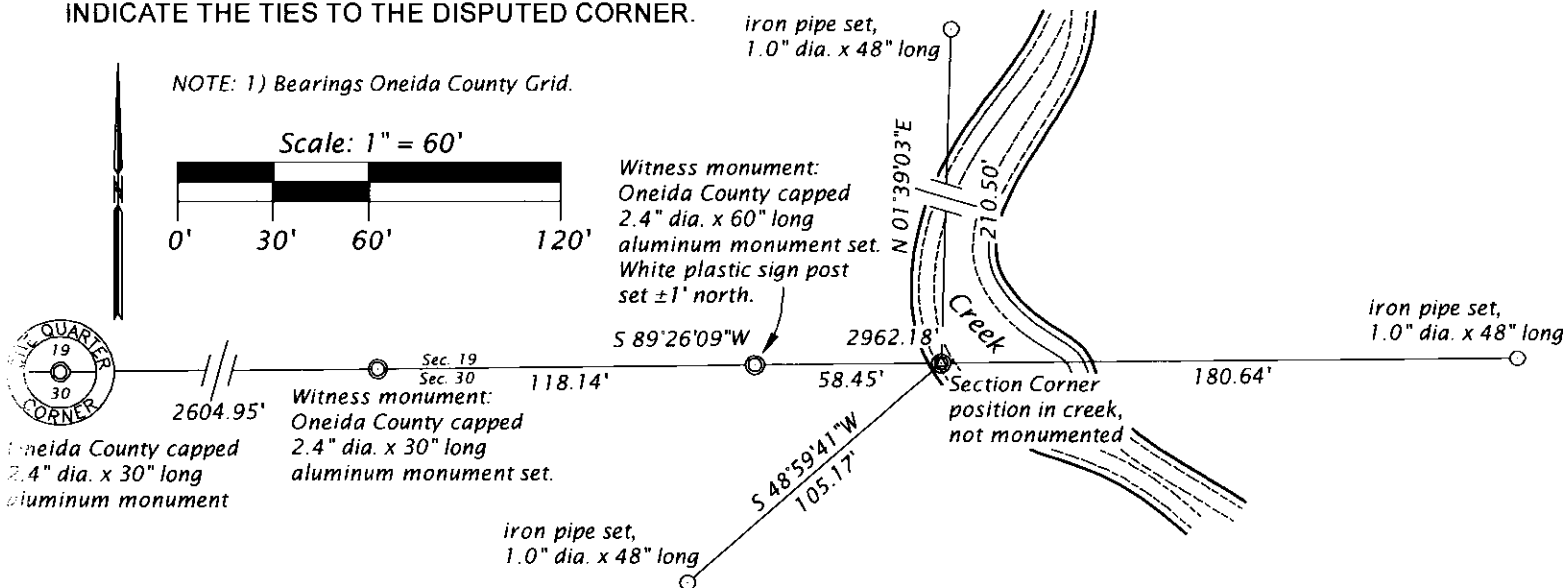
(c)(d)(e) PLAN VIEW OF CORNER WITH TIES TO AT LEAST 4 WITNESS MONUMENTS. IF IN DISAGREEMENT WITH PREVIOUSLY ESTABLISHED CORNER, SHOW THE DISTANCE BETWEEN THE TWO CORNERS AND ALSO INDICATE THE TIES TO THE DISPUTED CORNER.

1936 - February 21 - Ray Hall: CCC Book 5, page 20; original cor 19-20-29 & 30, identified by post found in beaver flowage agreeing (for distance) with stp. of original Pine bt. no sign of spruce. Set county monument by record course and distance from stump. This falls 0.9' SW of post found (find old post down where we put mon.). Also set new scribed 5x5 cedar post, no new bearings available.  
1957 - Becker, Ownes - Illinois surveyor, mapped by W. H. Stuth, 5/2/86 filed in NEPCO Book 2, page 101; identifies corner monument "by others" referenced by a 13" SW, N 26°E, 129.4' and a 10" SW, S48°W, 125.4'. Note: This map shows measurements to the S 1/16 and E 1/4 corners, and also to the E 1/16 and S 1/4 corners.

2016 - September 28 - James D. Rein, PLS, No. 1234 - After performing surveying ties to the E 1/4, S 1/16, E 1/16 and S 1/4, corners and making a comparative analysis of Becker measurements, I find no remaining evidence of Becker's bt's and determine Hall's monument has been obliterated, by creek erosion and extensive beaver activity. Because Becker's measurements are more harmonious along the east section line, I re-establish the corner position by extending and doubling the distance measured from the E 1/4 corner through the recovered S 1/16 corner. This position is located within 3 feet of a (Becker) distance-distance intersection with the recovered E 1/16 corner monument. Note: I do not accept the recovered O & I monuments as marking the S 1/4 and E 1/16 corners, because their positions appear to be established based upon an erroneous southwest section corner position.
