U.S. PUBLIC LAND SURVEY MONUMENT RECORD

(a) Corner location: Township 38 North Corner: North 1/4 Corner

Section 24 Range 9 East Original Surveyor: William Daugherty

County Oneida

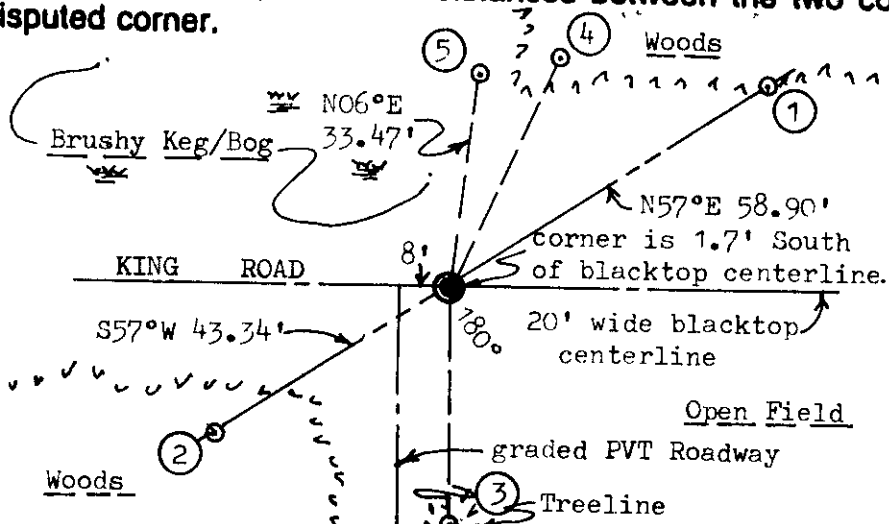
(c) (d) (e) Plan view of corner with ties to at least 4 witness monuments. If in disagreement with previously established corner, show the distances between the two corners and also indicate the ties to the disputed corner.

Witness Monument Ties:

- ① 2" dia. by 30" long aluminum pipe monument set with stamped Oneida County cap 6" above grade due to refusal below.
- ② Oneida County cap 6" above grade due to refusal below.
- ③ New BT 12" Fb S02°W 82.97' on old fenceline/treeline.
- ④ New BT 9" Fb double N24°E at 39.66'.
- ⑤ A 1.5" dia. reference pipe found loose and tipped to the North; could not plumb but drove deeper with 4" sq. x 1/4" stamped plate at top 32" high.

Scale: 1" = 30'

Found and accepted a 3/4" dia. uncapped iron pipe at this corner with undisturbed top nearly flush with existing blacktop roadway pavement. All original GLO survey corner evidence is obliterated. In 1909, Vaughn noted BT's for a post set at the corner, but neither were found by Maine in 1937, who noted he set an iron pipe in road at this quarter corner midway on a right line between opposite section corners, and also set iron pipe witness posts 50 links North and South of the corner pipe set; I found the North witness pipe as noted below, but the South witness pipe is now gone, undoubtedly due to adjacent private roadway grading. I left the iron pipe found at the corner in the new blacktop roadway mat and set standard Oneida County reference monuments at the ends of straight line thru the corner as noted for new ties below. I set a 1/4" dia. by 2 1/2" long PK nail in the top of the corner pipe found as a centering point for new ties. I could not replumb the old witness pipe found North so I drove it deeper and stamped a new tie distance on the 4" square by 1/4" thick plate cap, 32" above grade. The old witness pipe was painted yellow. This recovery was completed April 8, 1998 and witnessed by adjacent owners to south and north, who had stopped by to query about what I was doing, which resulted in a rather lengthy chat about old surveying history. I set a standard white poly corner marker post 10" ESE of the SW reference monument set.

Unless otherwise indicated, all BT witness monument ties are to a 1/4" dia. by 2.5" long PK nail with 1.25" dia. steel washer set in unblazed right face bark; and a PK nail with 2" dia. steel washer stamped BT also set in unblazed front face bark of each BT at DBH. All previous corner recovery notes from Wisconsin DNR and/or Oneida County survey records.
