I, James L. Will, do hereby certify that on the 29th day of June, 19 87, I found evidence of the Southeast Section corner of Section 76 Township 70 North, Range 10 East, Fourth Principal Meridian, as described hereon; and that from this evidence I established a new monument and accessories as described hereon to perpetuate the original location of this corner.

U. S. Public Land Survey Monument Record

Index No. Z-25

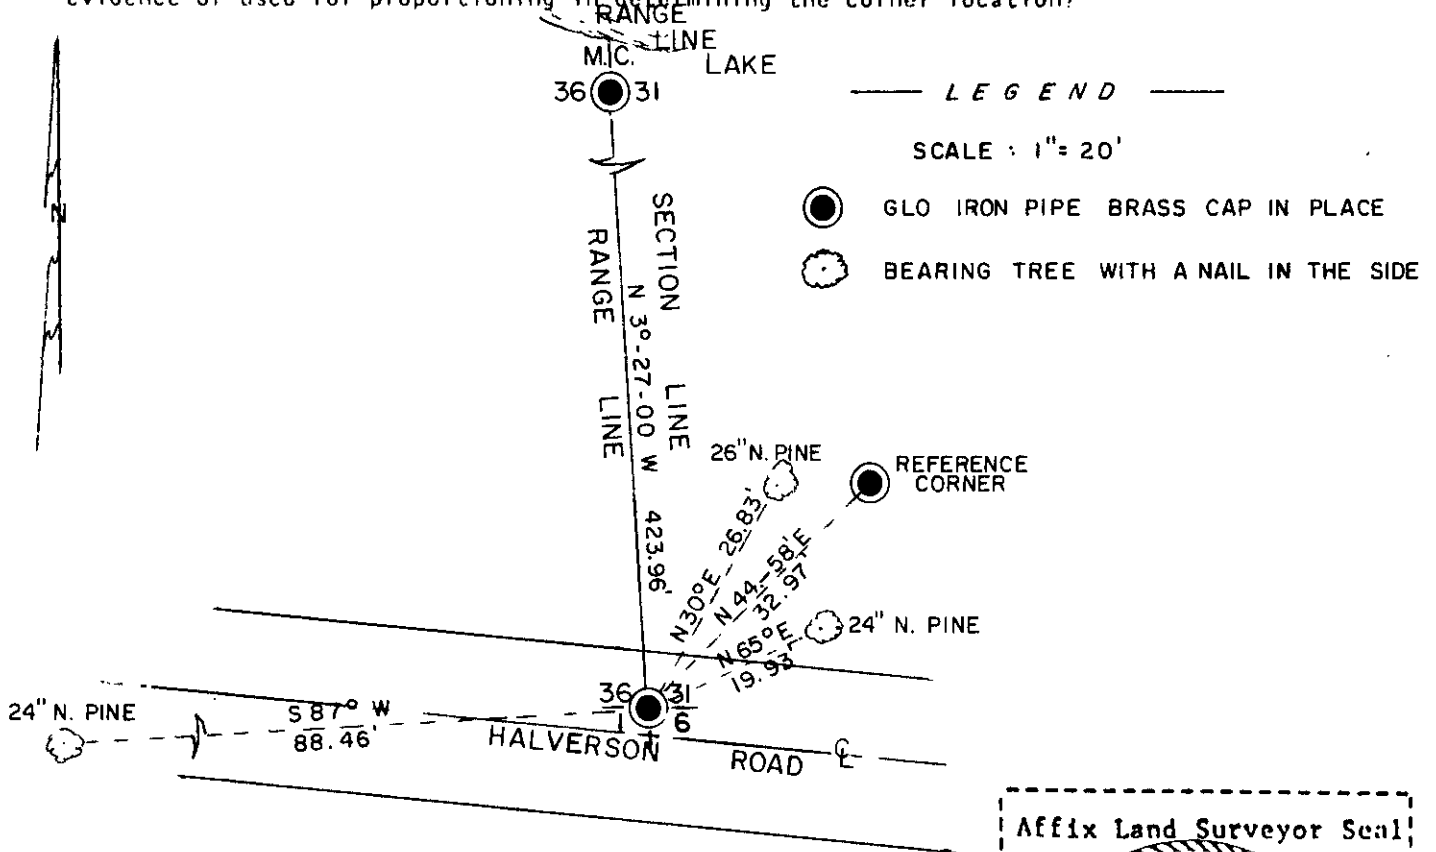
Found a GLO iron pipe brass cap 12" below the surface of Halverson Road. Found a GLO iron pipe brass cap reference monument N 44°-58' E 32.97'. Found the following bearing trees in place: 24" N. Pine N 55° E 19.93' (Measurements are to a nail in the side of 26" N. Pine N 30° E 26.83' the trees.) Centerline of E-W town road is 3' south.

blazed the following new bearing tree: 24" N. Pine S 87° W 82.46' (Measurement is to a nail in the side of the tree.) Set a plastic sign post 0.5' northeast of the GLO reference monument. Set a 1"x12" iron pipe over the brass cap.

See sketch below.
