CERTIFIED LAND CORNER RESTORATION

Index No. N-9

U.S. PUBLIC LAND SURVEY MONUMENT RECORD
ONEIDA COUNTY

WI CORNER IDENTIFICATION NO.: 43610170000

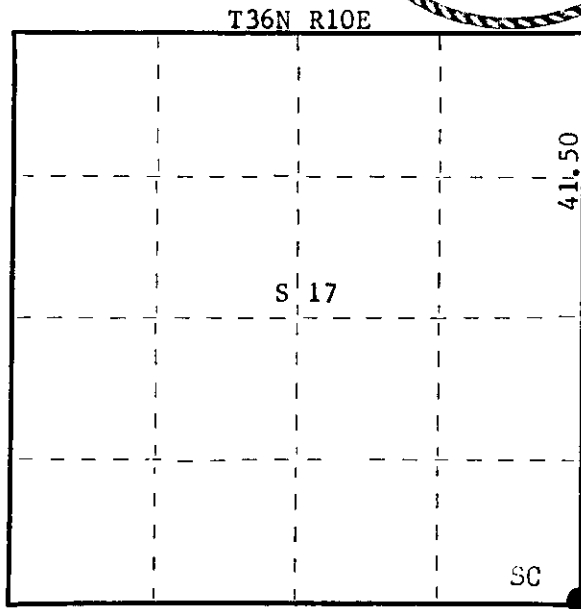
T36N R10E

17	16
20	21

Recovered OBT's - W. pine 16" (24") S70°W 164 links scribed S20 BT.
Jack pine 9" (12") N79°W 26 links scribing grown over.

As iron pipe was in perfect condition it was left in place.
Painted pipe and OBT's blue.

NBT - W. birch 10" S42°E 9.5 links scribed SC BT.

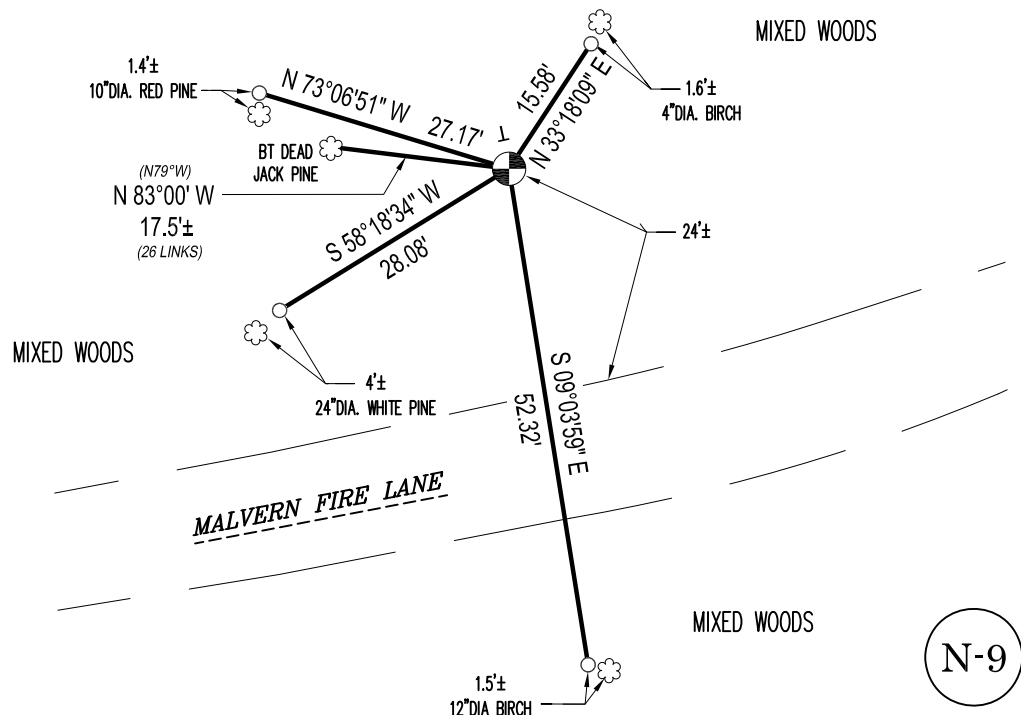
TIE SKETCH: Show minimum of four (4) horizontal tie distances to fixed witness monuments. Describe all monuments found or set.

2024: PLS 4001 FOUND 2.00" IRON PIPE WITH STAMPED BRASS CAP AND 1 BEARING TREE. BEARING TREE WAS DEAD AND MATCHED WELL WITH CORNER LOCATION. ACCEPTED AS CORRECT, SET 4 NEW TIES AND RE-TIED CORNER.

Bearings are based on the Oneida County Coordinate System NAD83 (2011).
