Stock No. 26273

U.S. PUBLIC LAND SURVEY MONUMENT RECORD

I William B. Cochran, do hereby certify that on the 14th day of February, 1990, I found evidence of the Meander Corner on SE Shore of Virgin Lake bet. Secs. 11 & 14 Township 38 North, Range 11 East, Fourth Principal Meridian, as described hereon; and that from this evidence I established a new monument and accessories as described hereon to perpetuate the original location of this corner.

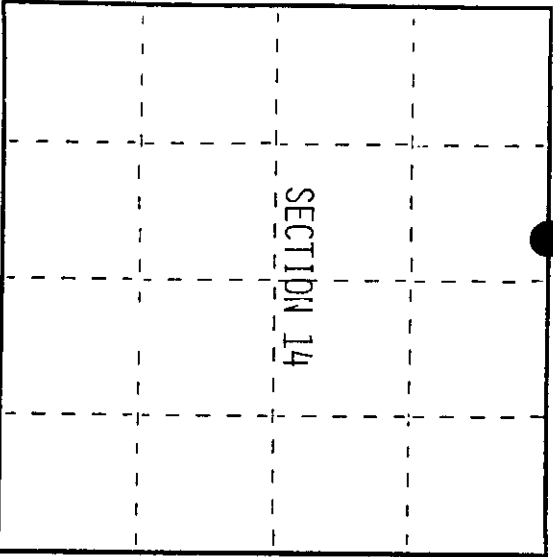
Found monument as described and in place, from which the following bears;  
Norway Pine 10" N18°45'E 22.44 feet

New corner reference;  
NW corner of building S82°E 30.20 feet

● = Corner monument restored.

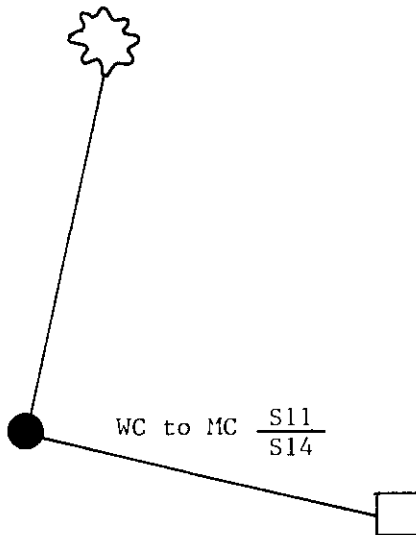
See drawing below.

10" Norway Pine (GLO Bearing Tree)  
N18°45'E, 22.44 feet

SE Corner of Building  
S82°E, 30.20 feet
